# Context and Issues during Post-Earthquake Rapid Evaluation of Buildings after the 2015 Nepal (Gorkha) Earthquake

Jitendra Bothara<sup>1</sup>, Dmytro Dizhur<sup>2</sup>, Rajesh Dhakal<sup>3</sup>, Jason Ingham<sup>4</sup>

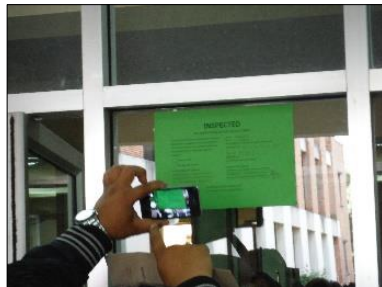
(a) Placarding by DUDBC of a hospital building in Kathmandu

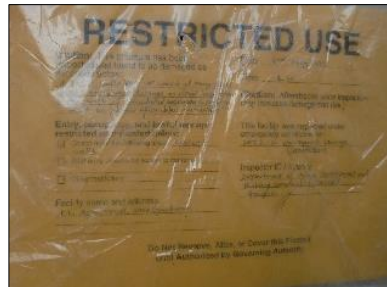
(b) Placarding by DUDBC of an apartment building in Kathmandu

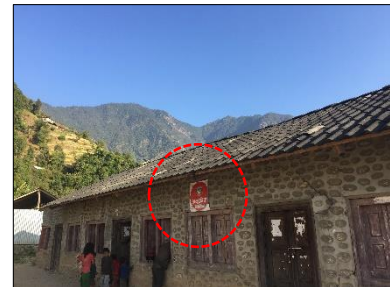
(a) A school building in a rural area placarded by the DoE as Unsafe

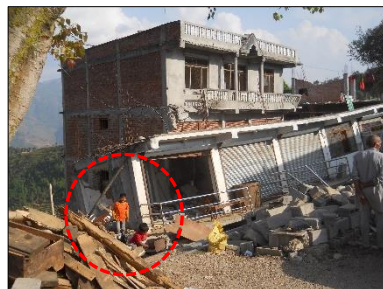
(a) Children playing in the debris of destroyed buildings

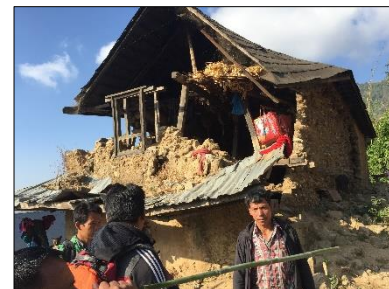
(c) An occupied residential building (deemed "unsafe")

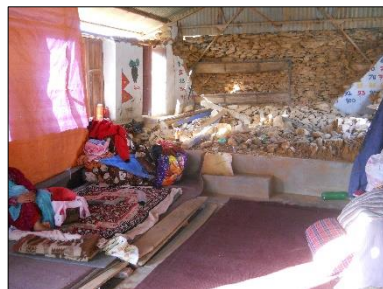
(d) School building with collapsed walls. The building was used for post-earthquake accomodation

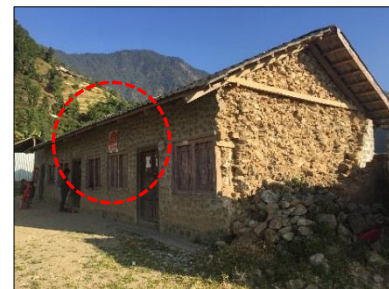
(f) Occupied school building placarded as "unsafe"

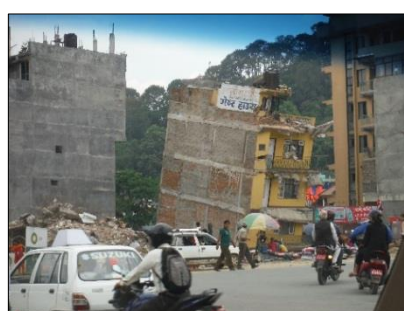
(b) Tilting building with no barricade along one of the main transport corridors in Kathmandu

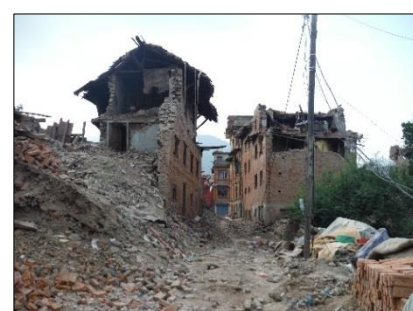
(c) Severely destroyed area with unrestricted access
